Cornholme Mount Zion Methodist Chapel Graveyard Memorial Survey

Background

Calderdale Methodist Circuit is responsible for the graveyard at Cornholme. Some of the memorials contained in the graveyard are in an unstable condition and have the potential to cause harm or serious injury. **A survey was undertaken in Feb 2026 to consider the state of memorials**, to address safety concerns. This was undertaken by a firm of building contractors with vast experience in graveyard work. This has become especially important following the tragic events at Rawtenstall.

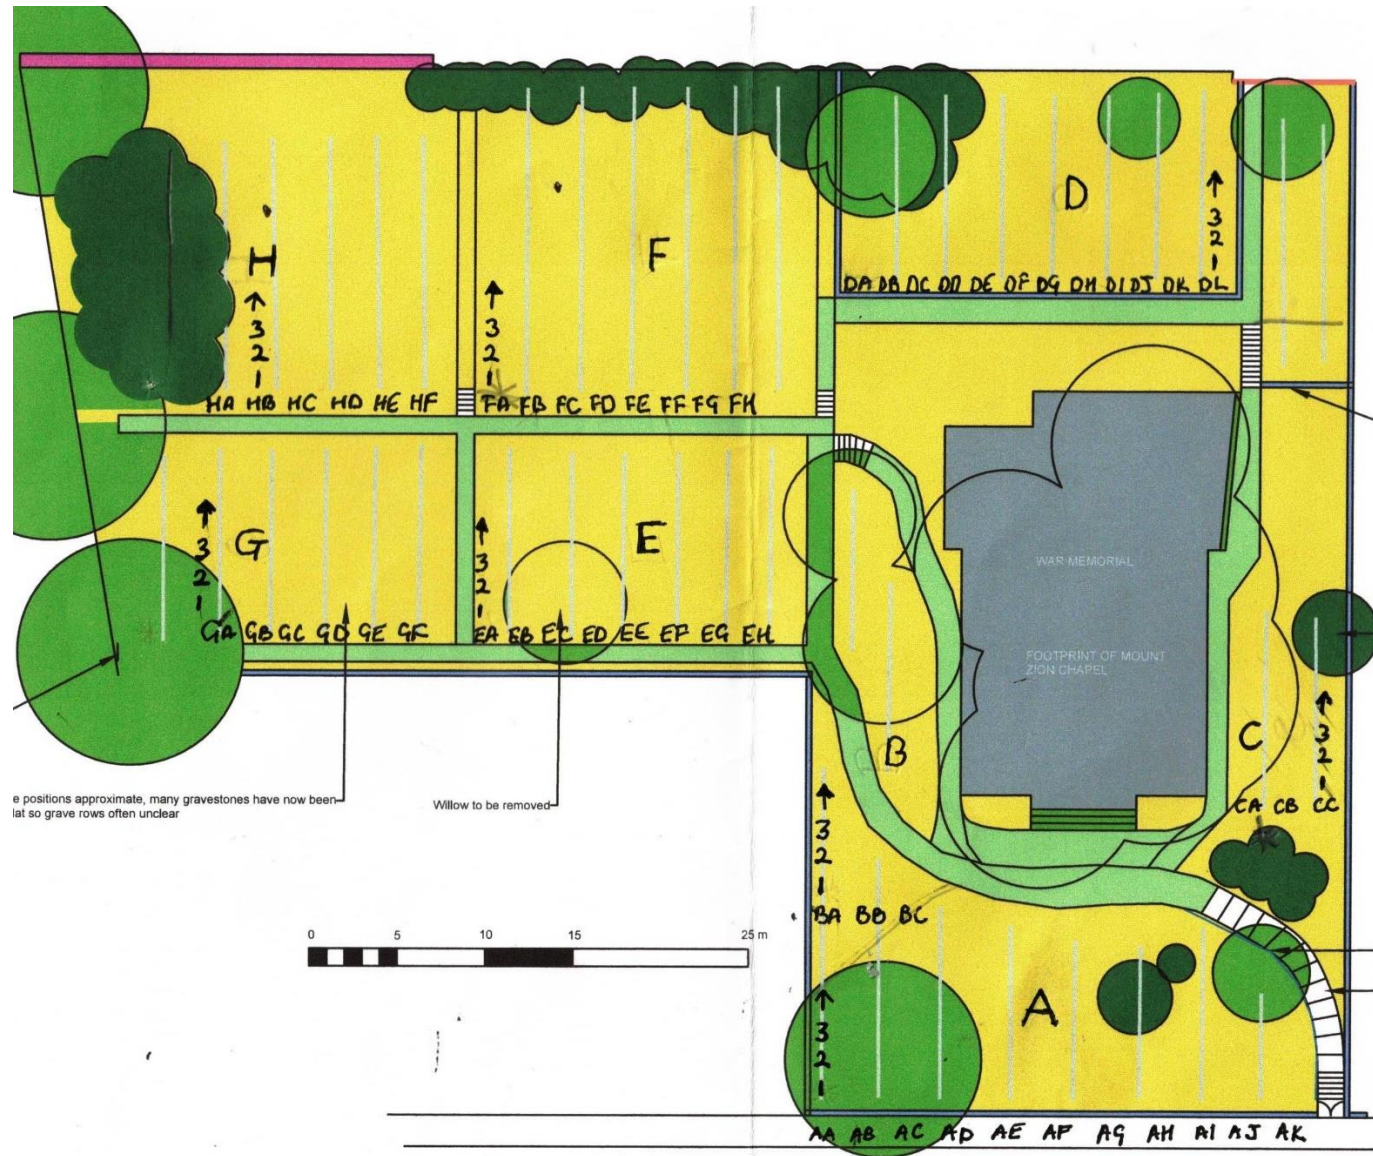
The Graveyard at Cornholme is on several different levels, therefore the graveyard was split into sections, this allowed for a more detailed mapping of the graves in question. Overall, there are 8 sections, labelled A – H. In each section the graves are started on the left-hand side and each grave is given an alphabetic letter and number, this is combined with the section to allow each grave to be uniquely identified. Please see the attached image for more details
